**Algonquin Incremental Market Project  
FERC Third-Party Compliance Monitoring Program**

**Daily Compliance Monitoring Reports**

## Site Inspection EV-2761

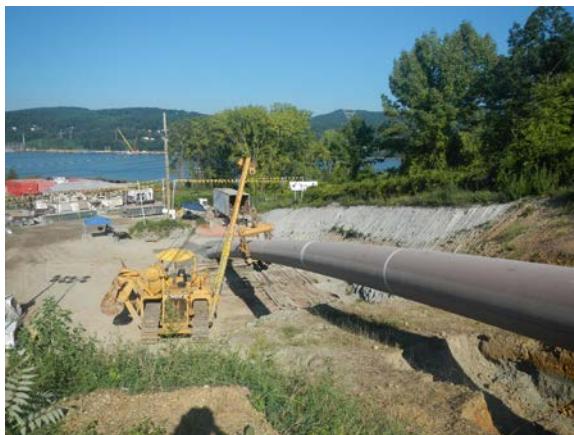
**Title:** 08-28-16  
MP 3.93 inactive pull-back at Hudson River HDD east side.

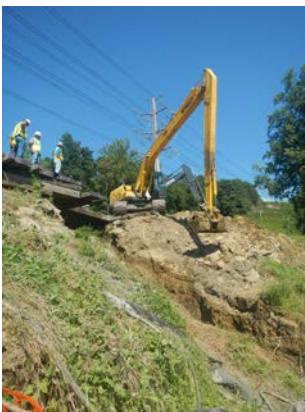
**Title:** 08-28-16  
MP 2.99 excavation over HDD centerline to wetland A14-SPLR- W100 boundary at Hudson River HDD west.

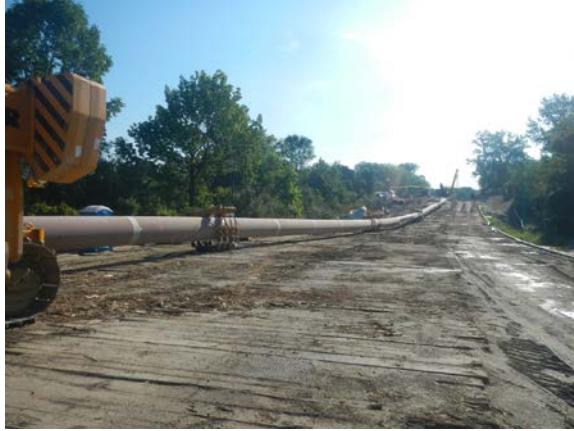
**Title:** 08-28-16  
MP 4.02 inactive pull-back at Hudson River HDD east side.

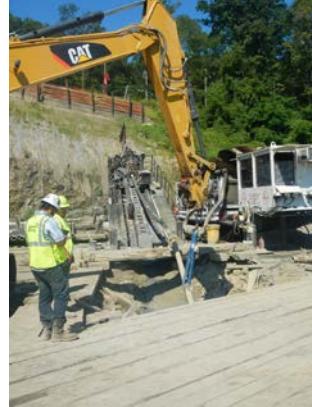
**Title:** 08-28-16  
MP 3.00 deformation in drill stem at rig - Hudson River HDD west during installation.

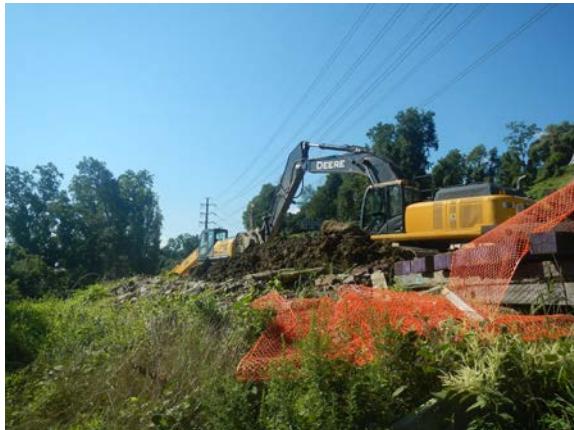
**Title:** 08-28-16  
MP 3.00 upland trench spoil from HDD centerline stored at Hudson River HDD west.

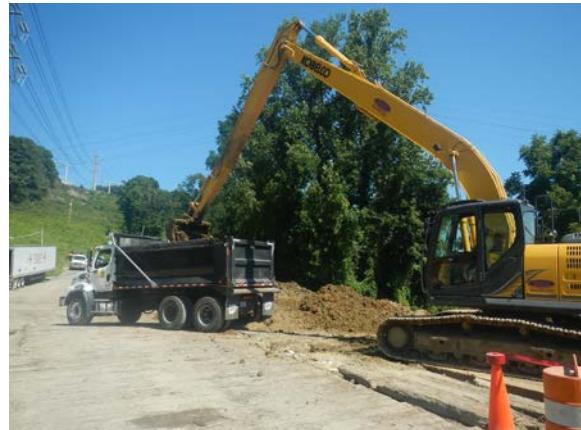
**Title:** 08-28-16  
MP 3.00 upland trench spoil loaded onto dump truck at Hudson River HDD west.

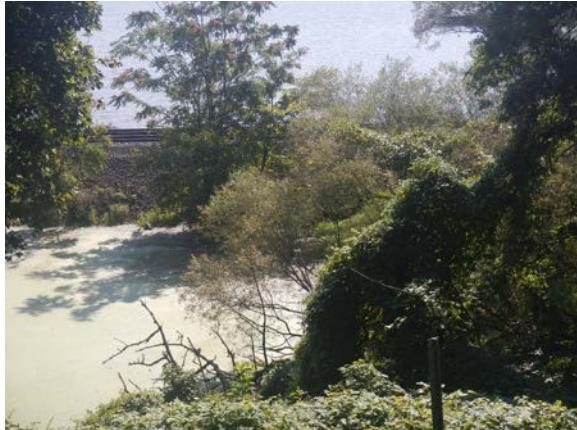
**Title:** 08-28-16  
MP 3.00 pond north of A14-SPLR-W100  
at Hudson River HDD west.

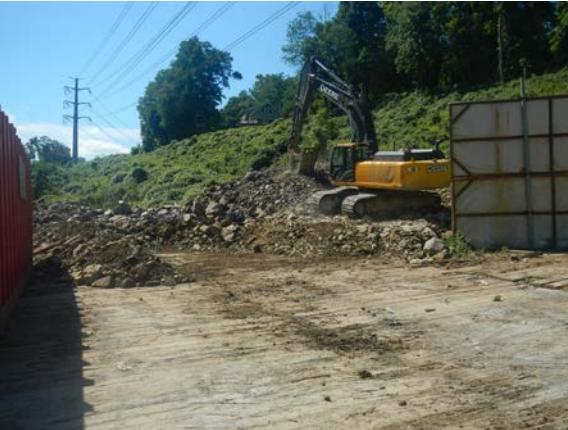
**Title:** 08-28-16  
MP 3.00 upland coffer for spoil storage  
constructed at Hudson River HDD west.

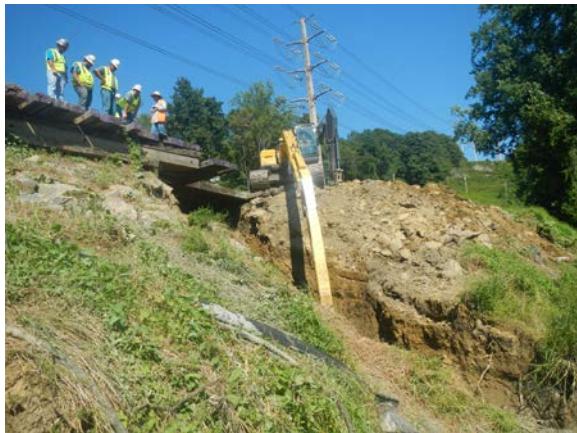
**Title:** 08-28-16  
MP 2.99 excavation over HDD centerline to  
wetland A14-SPLR- W100 boundary at  
Hudson River HDD west.

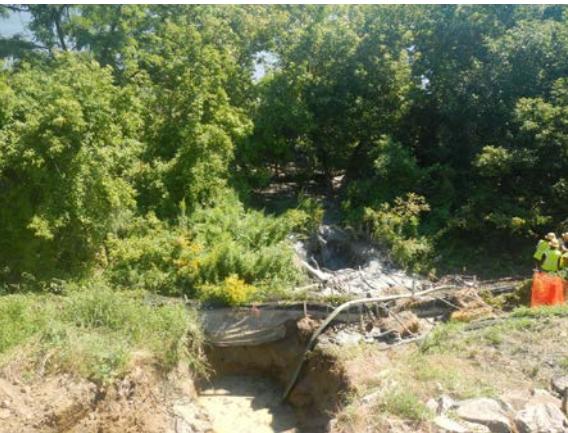
**Title:** 08-28-16  
MP 3.01 submersible mud relay pumps in  
IR in wetland A14- SPLR-W100 at  
Hudson River HDD west.

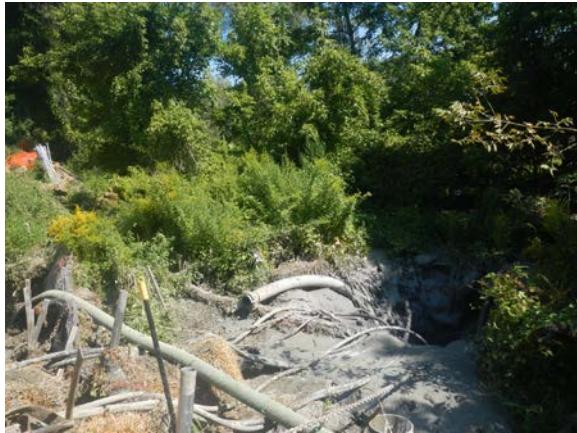
**Title:** 08-28-16  
MP 3.01 submersible mud relay pumps in  
IR in wetland A14- SPLR-W100 at  
Hudson River HDD west.

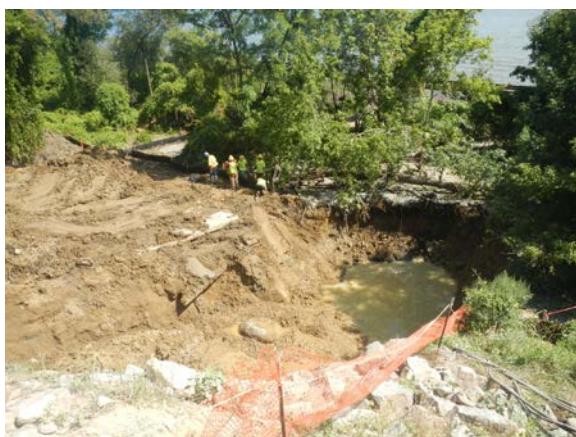
The CM then reported observations to the Compliance Manager and sent him e-mail site photographs. The Compliance Manager, assistant Compliance Manager, FERC Project Manager, and FERC Environmental Compliance Manager confirmed that this was in violation of the FERC Certificate. Additionally, they indicated that another conference call with AIM project senior management was necessary for their evaluation of environmental compliance at this site. Discussions with the FERC staff regarding the compliance level for the excavation within wetland A14-SPLR-W100 are ongoing.

**Title:** 08-29-16  
MP 3.01 unapproved ground disturbance in wetland A14-SPLR- W100 at Hudson River HDD west.

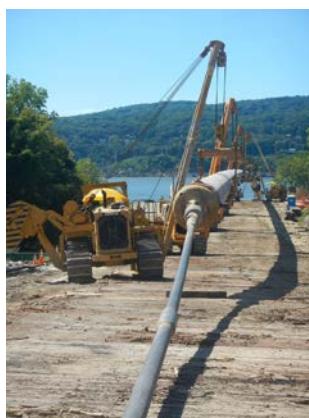
**Title:** 08-29-16  
MP 4.08 pipe segments suspended drill stem at Hudson River HDD east side.

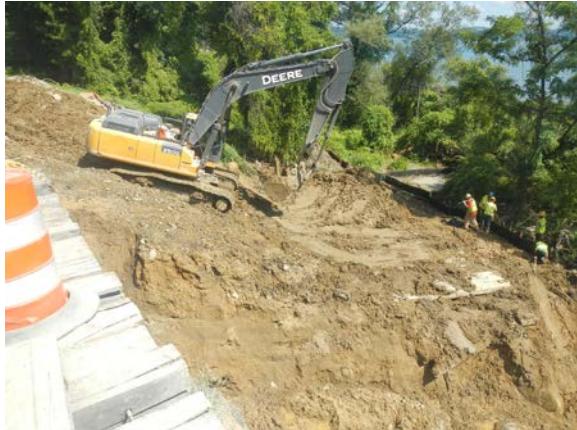
**Title:** 08-29-16  
MP 3.01 unapproved ground disturbance in wetland A14-SPLR- W100 at Hudson River HDD west.

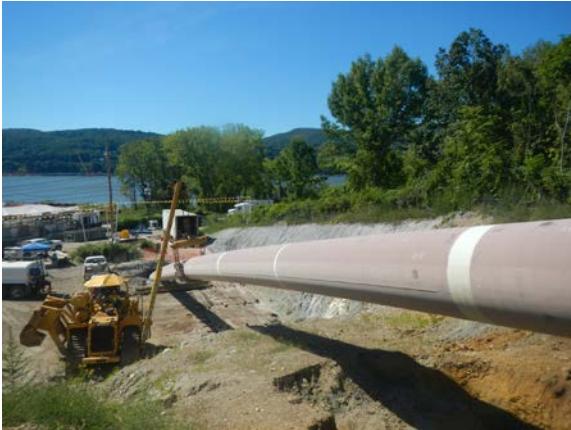
**Title:** 08-29-16  
MP 3.93 suspended pipe at Hudson River HDD east side installation.

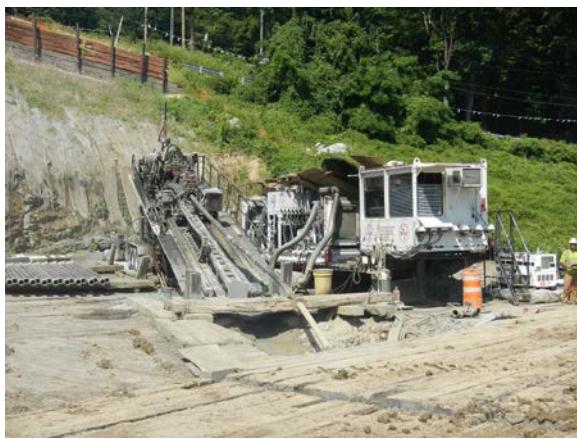
**Title:** 08-29-16  
MP 3.00 deformation in drill stem at rig - Hudson River HDD west during installation.

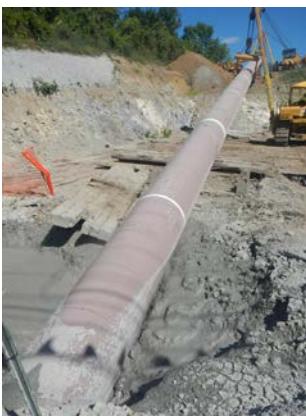
**Title:** 08-29-16  
MP 3.91 insertion point for Hudson River HDD east installation.

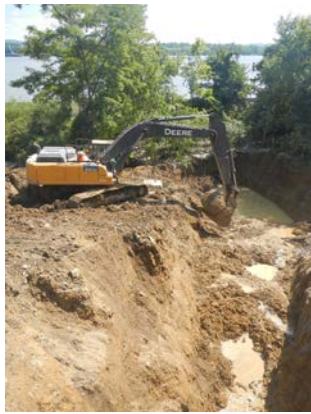
**Title:** 08-29-16  
MP 3.01 unapproved ground disturbance in wetland A14-SPLR- W100 at Hudson River HDD west.

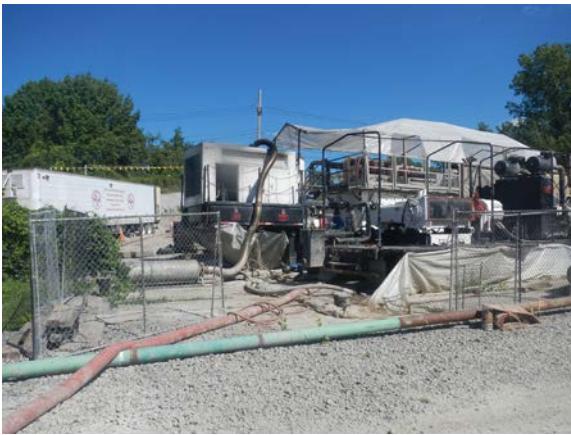
**Title:** 08-29-16  
MP 3.91 mud recycling rig in secondary containment at Hudson River HDD east.

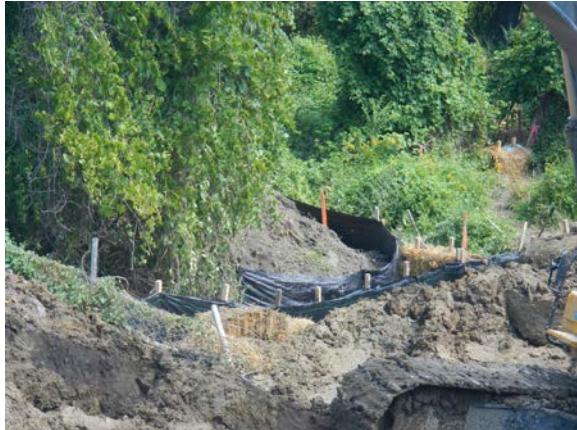
**Title:** 08-29-16  
MP 3.01 unapproved ground disturbance in  
wetland A14-SPLR- W100 at Hudson River  
HDD west.
